Proposed Residential Development,
Dundrum, Dublin 14

Quality Audit

Document Ref: P21-138-UQA-GEN-RP-001

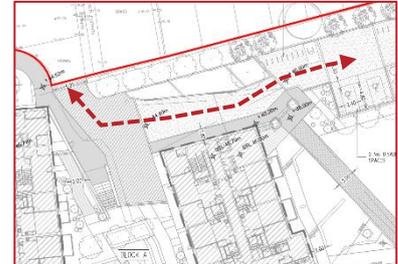
3.4.1 Problem

Summary: It is unclear if the proposed development will be sufficiently lit during the hours of darkness.

Information regarding public lighting within the proposed development has not been provided to the Audit Team and it is therefore unclear if the development will be sufficiently lit during the hours of darkness. This problem may be exacerbated by the horizontal alignment within the proposed development between the access and mobility impaired parking spaces at surface level, which includes a number of sharp changes in direction and abrupt narrowing of the carriageway. Drivers traveling to/from these parking spaces may be insufficiently aware of the kerb line during the hours of darkness resulting in potential kerb strikes and material damage.

Additionally, if the proposed development is not sufficiently lit during the hours of darkness there is a risk that inter-visibility between drivers and vulnerable road users will be reduced resulting in an increased risk of vehicle-pedestrian collisions.

Ensure the proposed development is sufficiently lit during the hours of darkness.

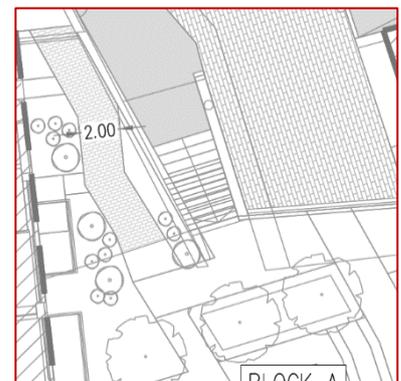
3.4.3 Problem

Summary: Tactile paving has not been indicated at the top and bottom of steps within the proposed development which may lead to visually impaired pedestrians being insufficiently aware of the hazard.

Tactile paving has not been indicated at the top and bottom of steps within the proposed development. This may lead to visually impaired pedestrians being insufficiently aware of the height hazard resulting in them continuing towards the steps and falling from a height.

Corduroy hazard tactile paving should be provided at the top and bottom of steps within the proposed development.

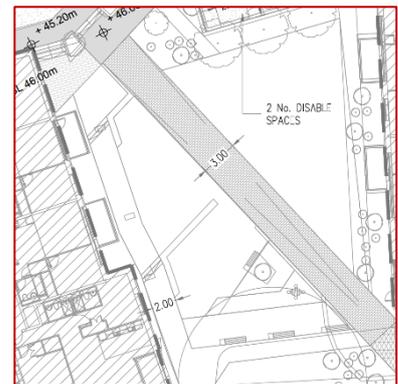
3.4.4 Problem

Summary: *The gradient of footways within the development is unclear and may lead to slips, trips and falls if steeper than 1:20.*

Ramps have been indicated throughout the footway network within the proposed development. The gradient of these ramps has however not been indicated. Should ramps be provided at a gradient that is in excess of 1V:20H, elderly, or mobility impaired pedestrians, particularly wheelchair users, and cyclists may experience difficulty ascending/descending the ramps resulting in potential slips and falls.

Ensure the proposed gradients are not steeper than 1V:20H.

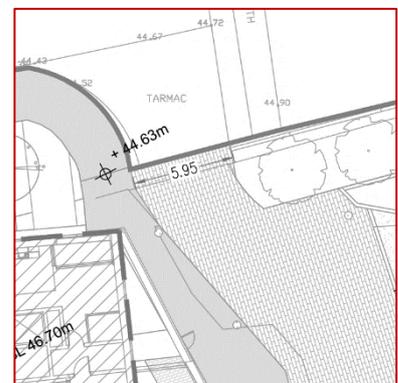
3.4.5 Problem

Summary: *Junction control, or priority, has not been indicated at the access to the proposed development.*

The junction control (stop, yield etc.), and thus priority, at the development's access has not been indicated. The absence of adequate road markings and signage may lead to driver confusion and hesitation resulting in drivers misinterpreting priority at the junction and entering the junction at the same time as opposing vehicles where there is an increased risk of side-swipe or side-on collisions.

Ensure the junction control, and priority, at the proposed development access is clear via signage and road markings.

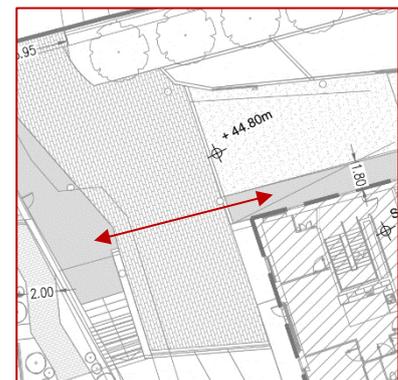
3.4.6 Problem

Summary: *A pedestrian crossing has not been indicated at the top of the basement carpark access ramp along the pedestrian desire line between Block A and Block B.*

Measures have not been indicated to allow pedestrians to safely cross from the footway in front of Block A to the footway in front of Block B at the top of the basement carpark access ramp, where a pedestrian desire line is likely to exist. Should pedestrians cross at this location, which is the shortest route between these footways, or elsewhere within the development, there is a risk that drivers entering/exiting the basement carpark will be less attentive to them increasing the risk of vehicle-pedestrian collisions.

A formal uncontrolled pedestrian crossing, including dropped kerbs and tactile paving if a level difference is proposed between the shared surface and footway, should be provided at the top of the basement carpark access ramp, ensuring drivers exiting the ramp have sufficient visibility to crossing pedestrians and cyclists.

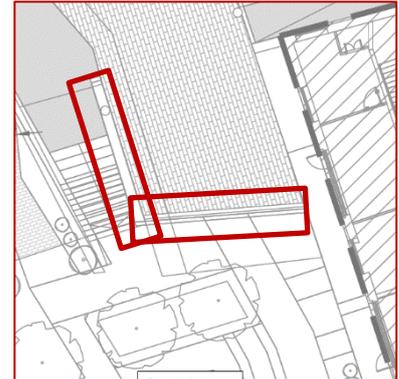
3.4.7 Problem

Summary: It is unclear if sufficient edge protection will be provided at surface level adjacent the basement carpark access ramp.

It is unclear from the drawing provided if sufficient edge protection will be provided at surface level adjacent the basement carpark access ramp. Insufficient edge protection may increase the risk of pedestrians and cyclists falling from a height onto the ramp below, leading to serious personal injury.

Sufficient edge protection should be provided at surface level adjacent the basement carpark ramp.

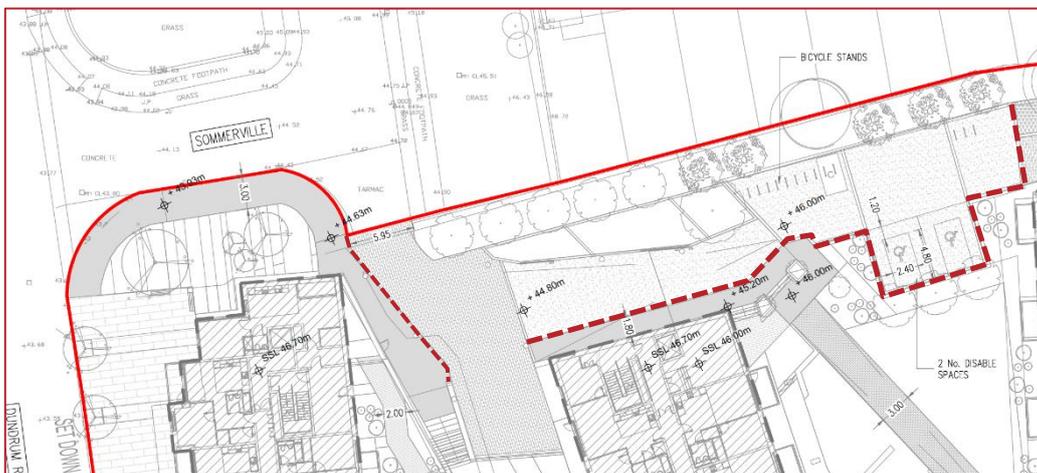
3.4.8 Problem

Summary: It is unclear if the footways at the development's ground level will be flush with the adjacent shared surface.

It is assumed that the route between the development access and the mobility impaired parking spaces/carpark at surface level is a shared surface. It is however unclear if the adjacent footways will be flush with the shared surface or at a different level. It is likely that visually impaired pedestrians will travel within the footways which will present a 'safe zone' for them where motorised vehicles will not enter. However, if the footways are flush with the shared surface, and a sufficient means of delineation not provided at the transition between the footways and shared surface, visually impaired pedestrians may inadvertently enter the shared surface leading to an increased risk of collisions with vehicles and cyclists.

If the footways and shared surface are flush a tactile strip should be provided at the transition between the two surfaces to advise visually impaired pedestrians of the transition. Sufficient colour contrast should also be provided between the two surfaces to further increase a visually impaired pedestrian's awareness of the road layout.

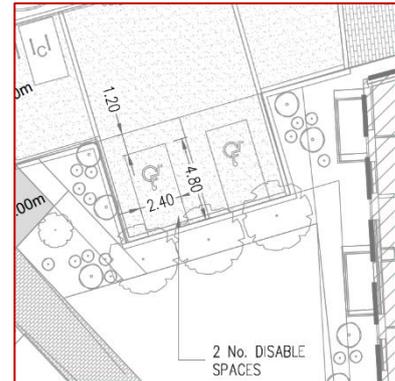
3.4.9 Problem

Summary: Absence of dropped kerbs and tactile paving at the mobility impaired parking spaces.

Mobility impaired parking spaces have been indicated adjacent to the northern side of the proposed development units.

It is unclear from the information provided if dropped kerbs and associated tactile paving are proposed at these parking spaces. The absence of dropped kerbs could lead to difficulties for mobility impaired road users in accessing the footpath once they leave their vehicle.

Provide dropped kerbs & tactile paving between the parking spaces to permit safe access to/from the footway.

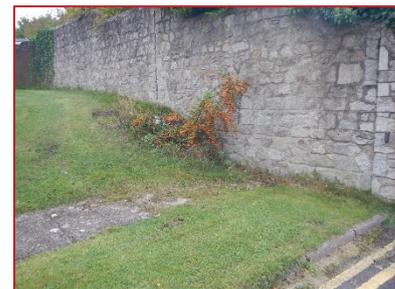
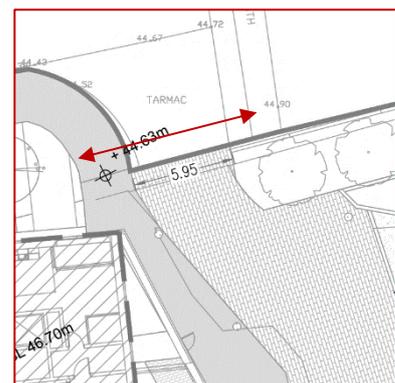
3.4.10 Problem

Summary: The existing footway on the eastern side of the Sommerville Estate access road terminates at the development boundary with no measures indicated for pedestrians to access the proposed footway on the western side of the road.

The existing footway on the eastern side of the Sommerville Estate access road terminates at the development boundary. Measures have not been indicated for pedestrians travelling to the development from the Somerville Estate to safely access the proposed footway on the western side of the road which is indicated as continuing into the proposed development. This could lead to pedestrians crossing the carriageway at a location where drivers may be less attentive to them increasing the risk of vehicle-pedestrian collisions.

Additionally, mobility impaired and visually impaired pedestrians will be unable to access the development from this footway resulting in them being unable to safely, and independently, navigate the road layout.

A pedestrian access to the development should be provided from the footway on the eastern side of the Sommerville Estate access road.

Alternatively, an uncontrolled pedestrian crossing should be provided at the development access to allow pedestrians access the western footway at this location. The crossing should be located where inter-visibility between drivers and crossing pedestrians is unobstructed.

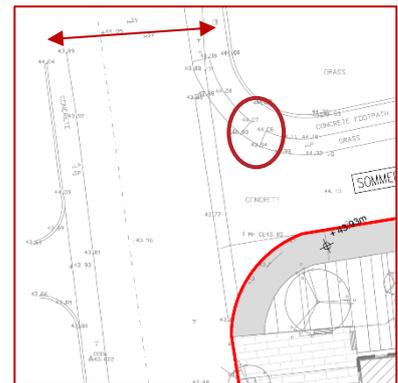
3.4.11 Problem

Summary: The route between Dundrum Road, to the north of the Sommerville Estate Access, and the proposed development does not include safe pedestrian crossing facilities for the visually and mobility impaired.

The route between Dundrum Road, to the north of the Sommerville Estate Access, and the proposed development does not include safe pedestrian crossing facilities for the visually and mobility impaired. There are existing dropped kerbs provided on either side of the Sommerville Estate access, however no tactile paving has been provided, nor do the dropped kerbs align with each other.

While it is acknowledged that this is outside the extents of the proposed development, it is likely that pedestrian trips generated by the proposed development will use this route to access public transport and other services located to the north. The lack of tactile paving at, and the alignment of, the crossing may lead to visually impaired pedestrians inadvertently entering the carriageway, and potentially being directed into the Dundrum Road carriageway rather than towards the opposing crossing point, where they are at an increased risk of being struck by a vehicle.

Additionally, there are limited existing pedestrian crossing facilities across the Dundrum Road to cater for pedestrian desire lines to/from the proposed development. If safe cross facilities are not provided along these pedestrian desire lines, there is a risk that pedestrians will cross at unsafe locations, increasing the risk of vehicle-pedestrian collisions.

The dropped kerbs on either side of the Sommerville Estate access should be amended such that they align with each other. The necessary tactile paving should also be provided at the dropped kerbs.

The developer should also liaise with Dún Laoghaire–Rathdown County Council to provide improved pedestrian crossing facilities across the Dundrum Road in the vicinity of the proposed development.

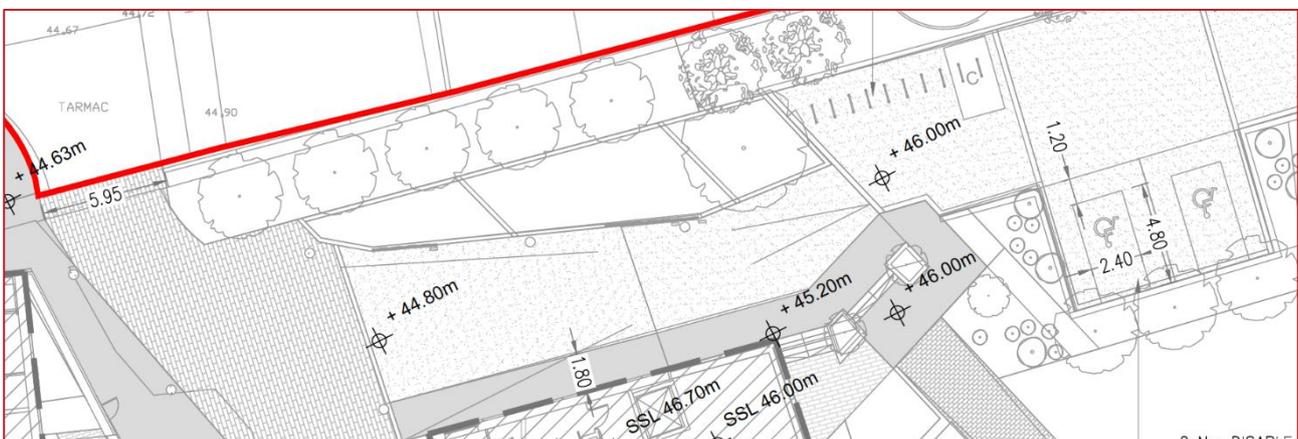
3.4.12 Problem

Summary: It is unclear if sufficient inter-visibility between drivers will be provided within the shared surface.

It is assumed that the route between the development access and the mobility impaired parking spaces at surface level is a shared surface. It is unclear however if sufficient inter-visibility between opposing drivers traveling along the shared surface will be provided due to the road furniture indicated within this area and

adjacent building boundaries/walls. If sufficient inter-visibility is not provided throughout the shared surface there is a risk of low speed head-on collisions particularly at locations where the carriageway narrows.

Ensure sufficient inter-visibility between opposing drivers within the shared surface is provided.

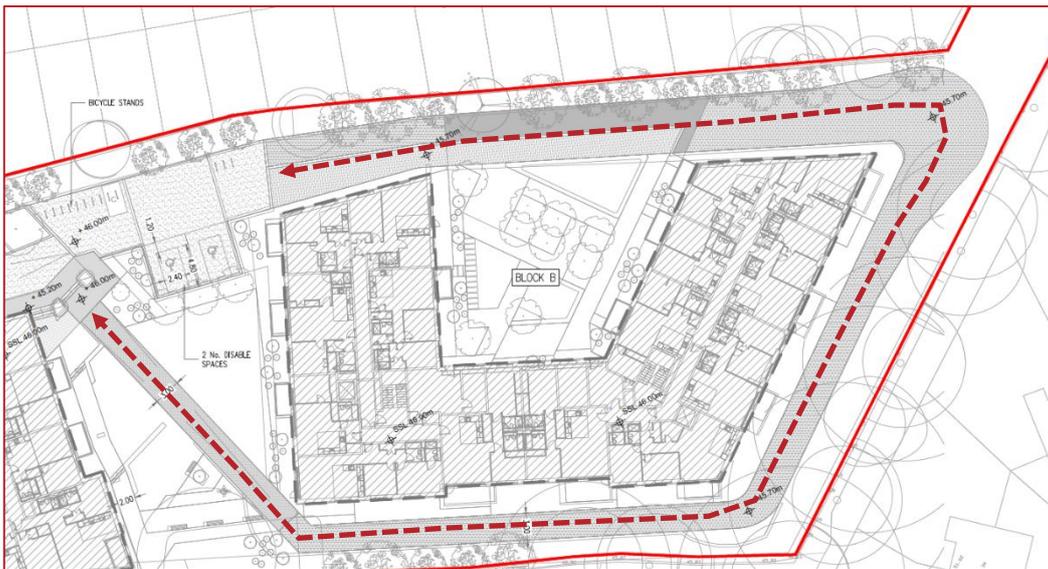
3.4.13 Problem

Summary: It is unclear if there is sufficient space provided for vehicles to safely travel along the road layout within the proposed development.

It is assumed that the route which circumnavigates Block B is intended for access for emergency vehicles (e.g. ambulance, fire tender etc.). Information regarding the swept path of vehicles has not been provided to the Audit Team and it is therefore unclear if these vehicles can safely enter, travel within, and exit the proposed development's road layout.

If sufficient space is not provided for vehicles to travel within the development, there is an increased risk of unsafe manoeuvres and material damage collisions, particularly where vehicle movement is restricted by overhanging or adjacent structures.

Ensure sufficient space is provided within the development for vehicles to safely enter, travel within, and exit the proposed development's road layout.

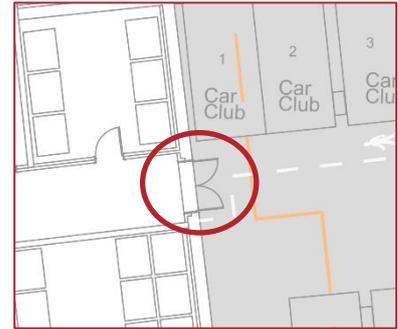
3.5.1 Doors within the basement carpark have been indicated as opening outward directly into the carpark carriageway. Drivers may not anticipate a door to open outwards, or for a pedestrian to suddenly step into the carriageway. It is unclear if this is indicative only or if it is intended for the doors to open outwards. Doors directly adjacent the carpark carriageway should open inward to avoid pedestrians suddenly entering the carpark carriageway. Should the proposed arrangement reflect fire egress requirements, measures should be put in place to provide a safe refuge for pedestrians exiting the building.

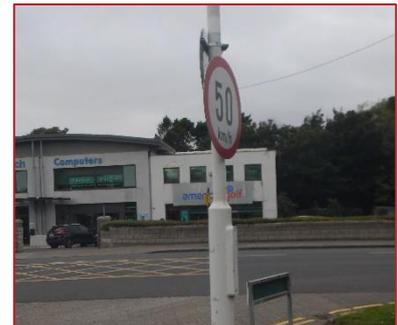
3.5.2 Existing 30kph and 50kph speed limit signs at the Sommerville Estate access facing drivers entering and exiting the estate respectively were noted as being twisted on their post at the time of the site visit such that they may not be sufficiently visible to drivers. The signs should be reoriented such that they are sufficiently visibility to the necessary stream of traffic.

4.7	Existing 30kph and 50kph speed limit signs at the Somerville Estate access facing drivers entering and exiting the estate respectively were noted as being twisted on their post at the time of the site visit such that they may not be sufficiently visible to drivers.	The signs should be reoriented such that they are sufficiently visibility to the necessary stream of traffic.	1	A

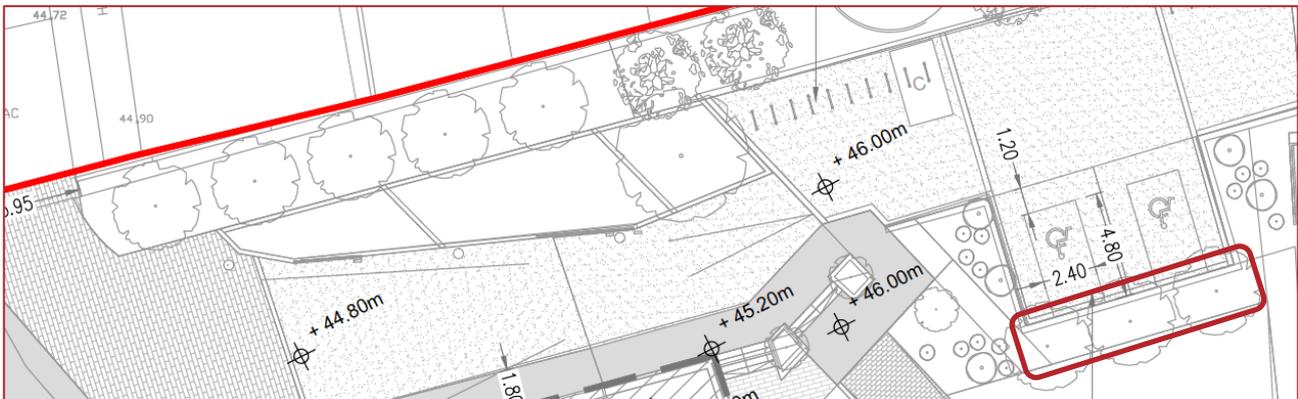
4.3.1 Issue

The path immediately to the rear of the mobility impaired parking spaces at surface level appears to be blocked by trees and may not be accessible for the mobility impaired, particularly wheelchair users, after exiting their vehicle. If this path is not directly accessible from these parking spaces, it is likely that mobility impaired drivers/passengers will have to travel a longer route through the shared surface to access the apartment blocks.

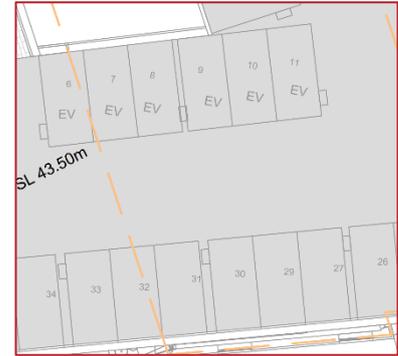
Electric Vehicle (EV) parking spaces have been indicated within the basement carpark. These typically require additional width to support a buffer zone to account for potentially different charging port connections on vehicles. The additional width allows space for electric cables, as well as user access to connect/disconnect the charging cables.

The EV parking spaces within the basement carpark appear to have similar dimensions as the standard parking spaces. There is a risk therefore that the required space will not be available to accommodate the necessary buffer zone and infrastructure at the EV parking spaces resulting in parking spaces having to be potentially removed, and potentially preventing the required number of EV parking spaces being provided.

Sufficient space should be provided at EV parking spaces in accordance with Section 7.6.16 of the Traffic Signs Manual (2019), Chapter 7 'Road Markings.'

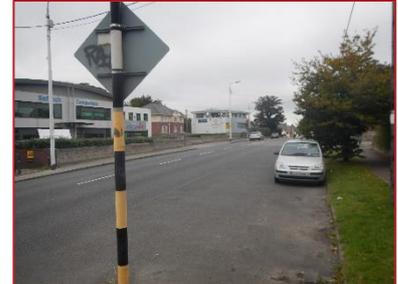
5.1.1 Issue

There is a lack of existing cycle facilities on Dundrum Road in the vicinity of the proposed development. The provision of extensive bicycle parking facilities within the development suggests that it is expected that cycling will be a popular mode of transport for residents of the development. If this is the case, it is likely that the volume of cyclists using the Dundrum Road will increase. A failure to provide formal cycle facilities on Dundrum Road may deter residents from cycling should they be less confident about sharing the carriageway with motorised vehicles.

The developer should liaise with Dún Laoghaire–Rathdown County Council to provide improved cycle infrastructure on Dundrum Road in the vicinity of the proposed development to support the use of cycling as a mode of transport for the development's residents.

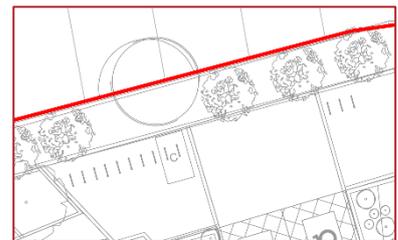
5.2.1 Issue

It is unclear if the proposed cycle parking stands at surface level will be sheltered. Users may be discouraged from using cycle stands if they believe the locations are unsafe, or if their bicycle will be exposed to the weather. This may encourage informal parking on footways or at property accesses, thereby restricting pedestrian access.

5.2.1	It is unclear if the proposed cycle parking stands at surface level will be sheltered. Users may be discouraged from using cycle stands if they believe the locations are unsafe, or if their bicycle will be exposed to the weather.	Ensure cycle parking stands are sheltered and, where located in areas away from high pedestrian volumes, ensure cycle stands are secure and the surrounding area sufficiently lit.	1	A

Ensure cycle parking stands are sheltered and, where located in areas away from high pedestrian volumes, ensure cycle stands are secure and the surrounding area sufficiently lit.
